McLaughlin Erectors, Inc.

Skylight Survey

Westfield Mall
Chesterfield, MO
05/26/05

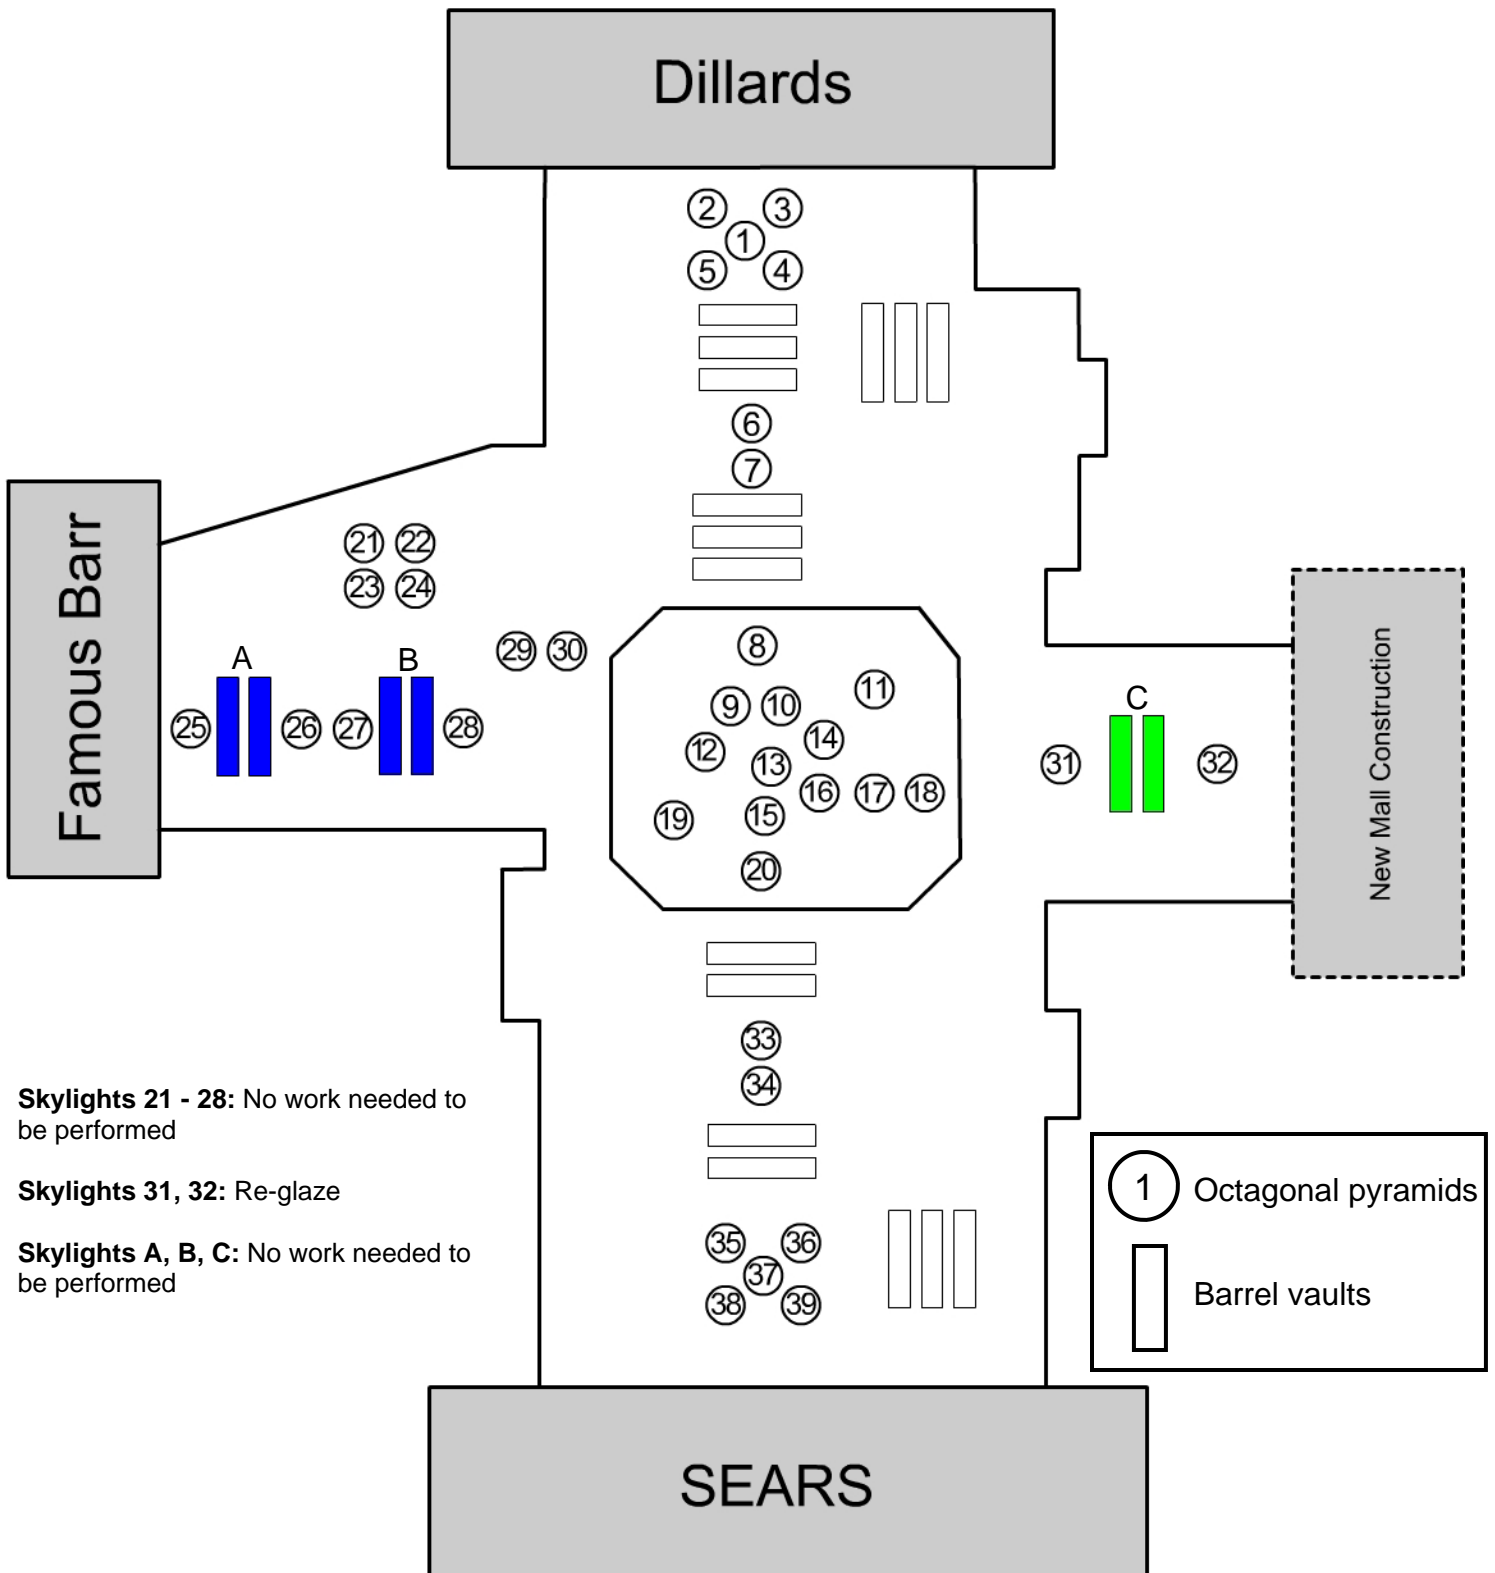
Appendix A

31 Plexiglass Octagonal Pyramids: There are 29 plex octagonal pyramids that need to be replaced. The frames are not of a sufficient design to allow for re-glazing. The gutter systems are of poor design and are not allowing the proper weeping of the system. The two naturalite octagonal pyramids **(31, 32)** need to be re-glazed. The sills can be renovated and flashing correctly installed to allow proper weepage and prevent any further damage to the curbs and sheetrock inside.

18 Single Plex Barrel Vaults: There are 16 barrel vaults that need to be replaced. These types of units are no longer manufactured and are vastly inferior compared to newer designs. The curbs are in good shape with minimal water damage. The 2 newer barrel vault units **(C)** appear structurally sound at this time and no action is needed.

Double Plex Barrel Vaults (A, B): These units appear to be in good condition and no action is needed.

Laminated Glass Octagons (21-28): These units are structurally sound and in good condition, no action is needed.

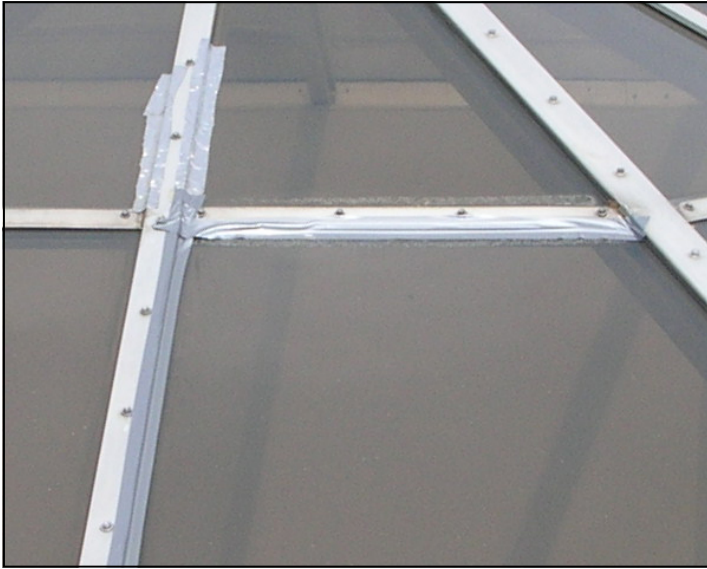
Plexiglass Octagons: There are 31 octagonal pyramid units glazed with single, 1/4" bronze plex. These units have reached the end of their useful service life. The plex is old and is sagging. The pressure cap gaskets have failed - warranting numerous caulking repairs. Some leaks are large enough as to require duct tape to slow leaking (see photos). The wood curbs are in good shape with slight water damage. There are typical problems with the existing old octagons. These problems include the plex falling out, skylights leaking badly, and improperly applied caulk.

Duct tape applied to slow leaking

McLaughlin Erectors Inc. recommends the 29 plex octagonal pyramids should be replaced. We recommend new CPI units aluminum frames and Quadwall polycarbonate glazing. Another options would be to go back with a like system that would give the dame look, but would not be as thermally efficient. The alternative Wasco systems would be double glazed acrylic with a steeper pitch and a UV inhibitor used in the acrylic.

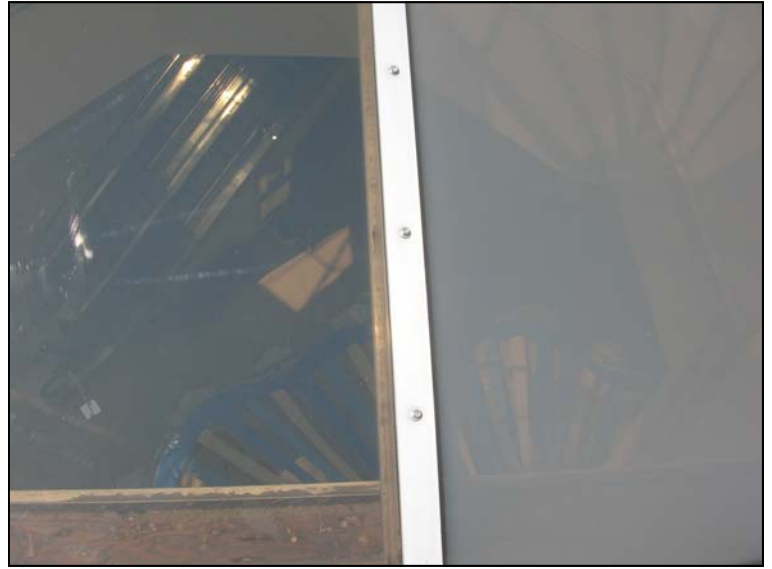
Some problems that are not typical include deteriorated lexan that was installed upside down with the UV on the inside of the system causing fogging (see photos). Some skylights have loose gutter screws as well. The pressure caps on the hips of the old octagonal pyramids are not extruded aluminum. They are flat, then formed and therefore do not hold their shape and will eventually lose the pressure necessary to hold and keep a watertight seal.

Installed properly vs. Upside down (fogging)

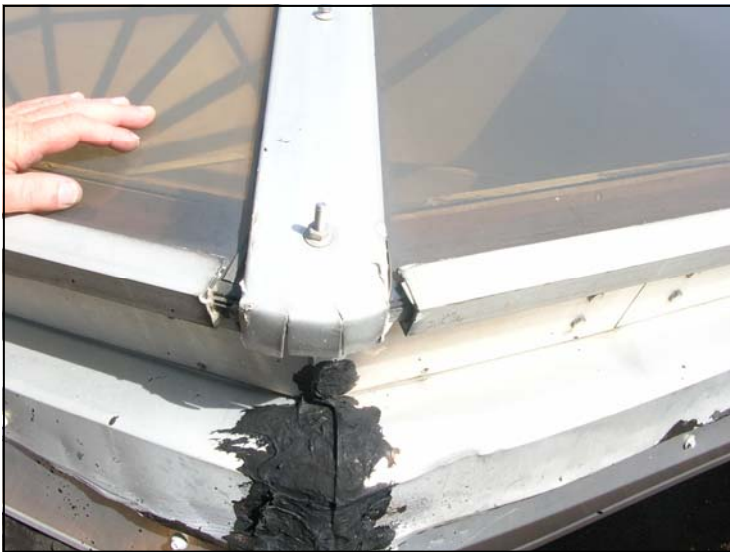
Improperly formed pressure caps on hip.
Not extruded aluminum.

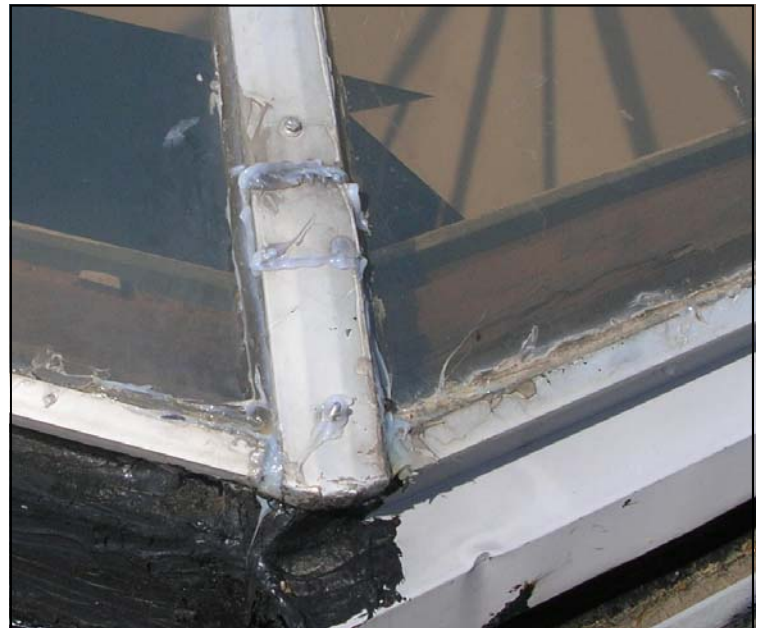
Old repairs - improperly applied caulk and roof tar on flashing.

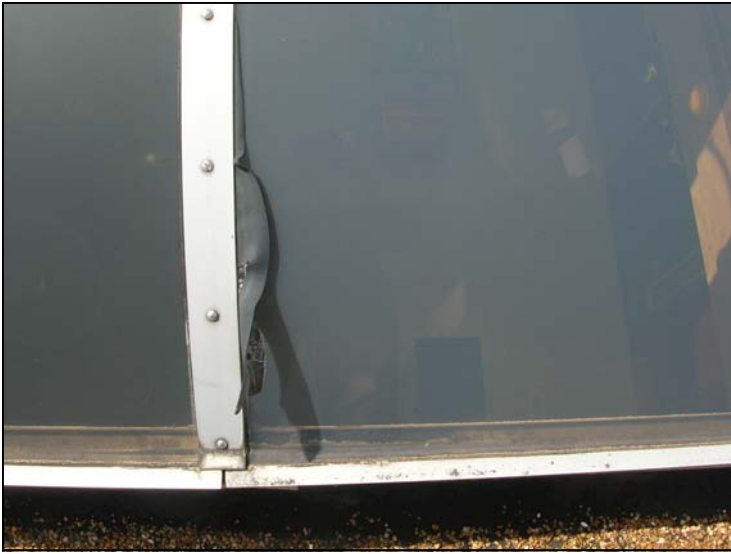
Gasket failure with improper fix

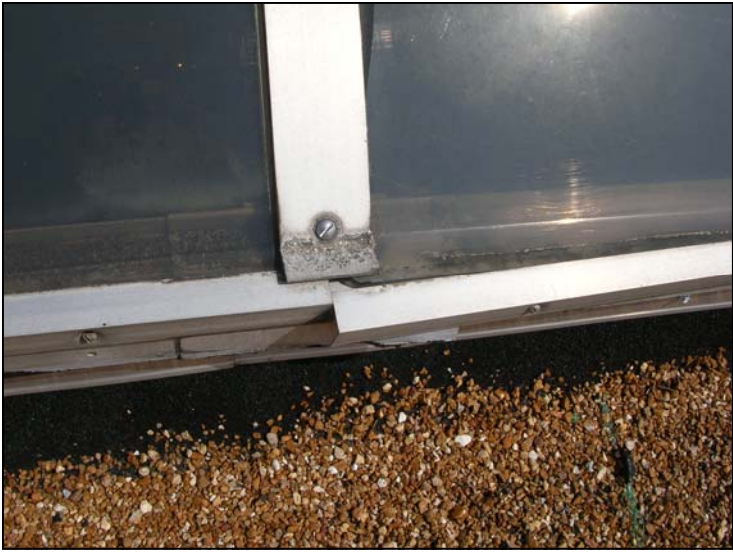
Frame and flashing failing

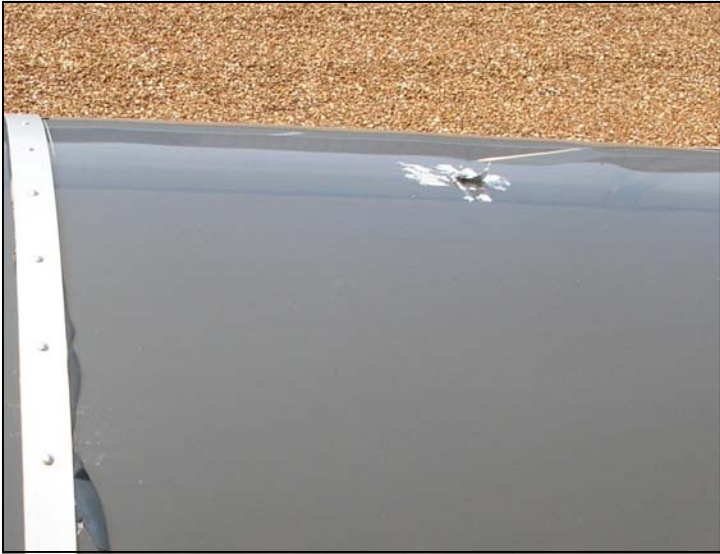
Broken piece of plex and failed gasket

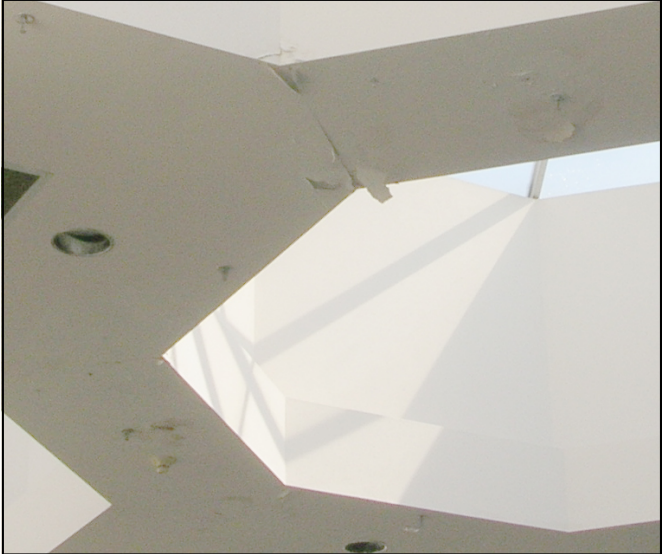
Sheetrock damage caused from leaks

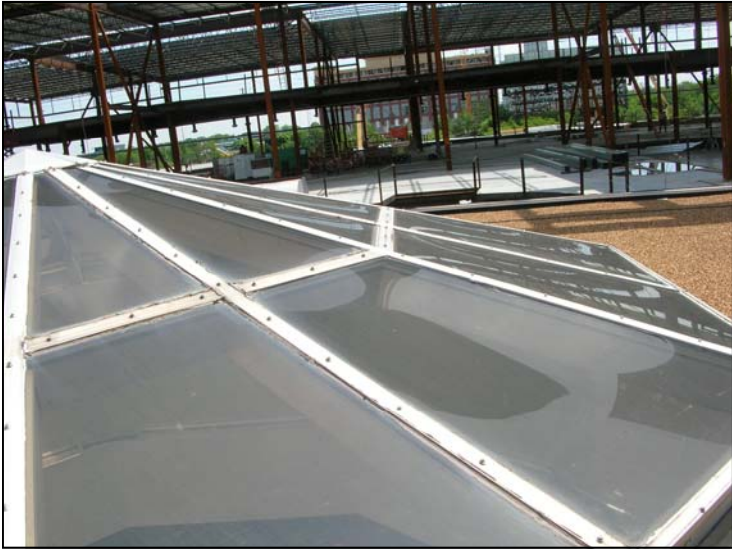
The original skylights are almost 30 years old. They are consistent with that of a low end commercial quality and typical for the application for which they have been used. Acrylics are produced using petroleum distillate which causes the material to eventually dry out. The resulting *crazing* (a series of small cracks which develops in the surface of the acrylic) weakens the material and will eventually develop into full fledged cracks due to stresses caused by their mal expansion and contraction of the acrylic. The sagging of the plex occurs when acrylic is installed flat or on a low slope.

Sagging Plex

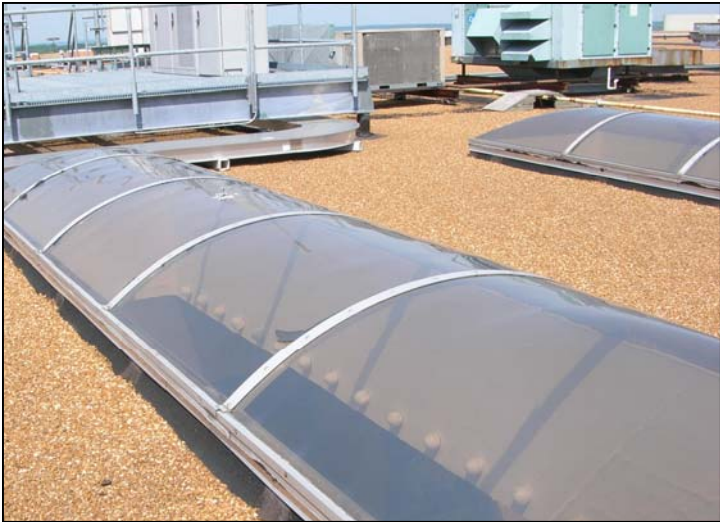
Heat distortion
